Enbridge Mackinac Straits ILI Review

NPS 20 Pipeline
Enbridge Line 5;
East and West Mackinac Straits

Report May 12, 2016

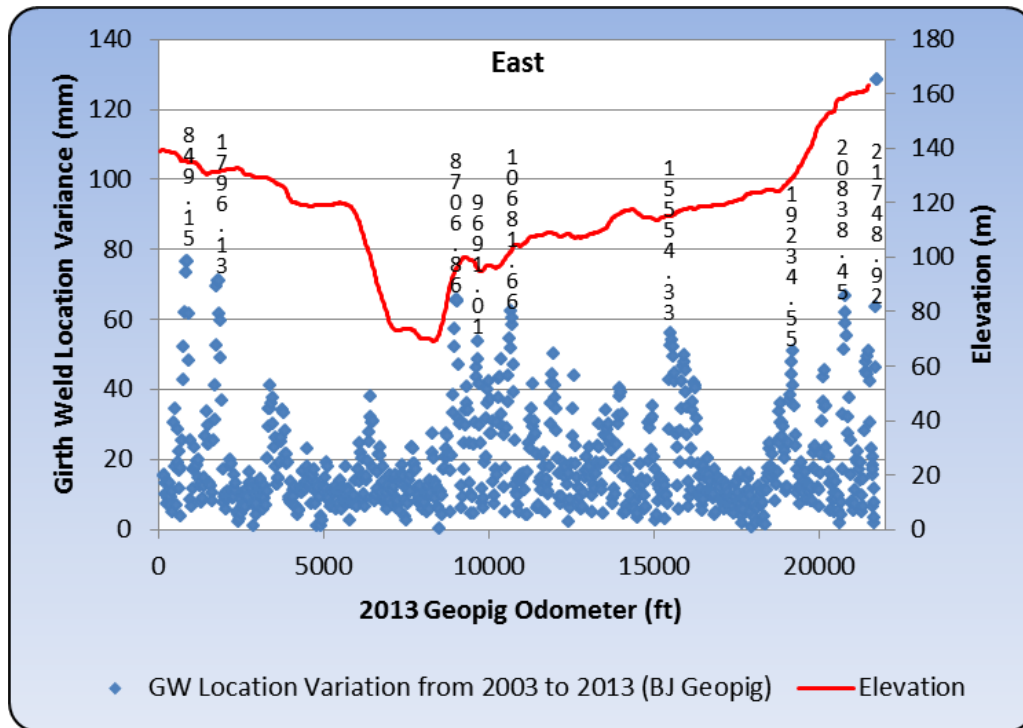
Figure 18. Pipeline horizontal movement as measured by the BJ Geopig in the East crossing.

Comparing previous Geopig inspections to the 2013 data it was found that the greatest horizontal displacement in the data was noted in the East segment (Figure 17) at the end of the inspection and was 163mm (6.4") and in the West segment (Figure 18) at the beginning of the inspection and was 172mm (6.8"). This amount of deviation has been determined to impart less than 0.02% strain as it acts over a long length. Both of these locations are onshore. The 2013 odometers for the greatest deviations are noted in the figures.
