Elk River Chain of Lakes Watershed Management Plan

April 18th, 2016 | Final Draft

Authors: Lauren Silver, Elliot Nelson, Brandon List, Kevin Peterson, Stephanie Miller – Advisor: Allen Burton, Ph.D.

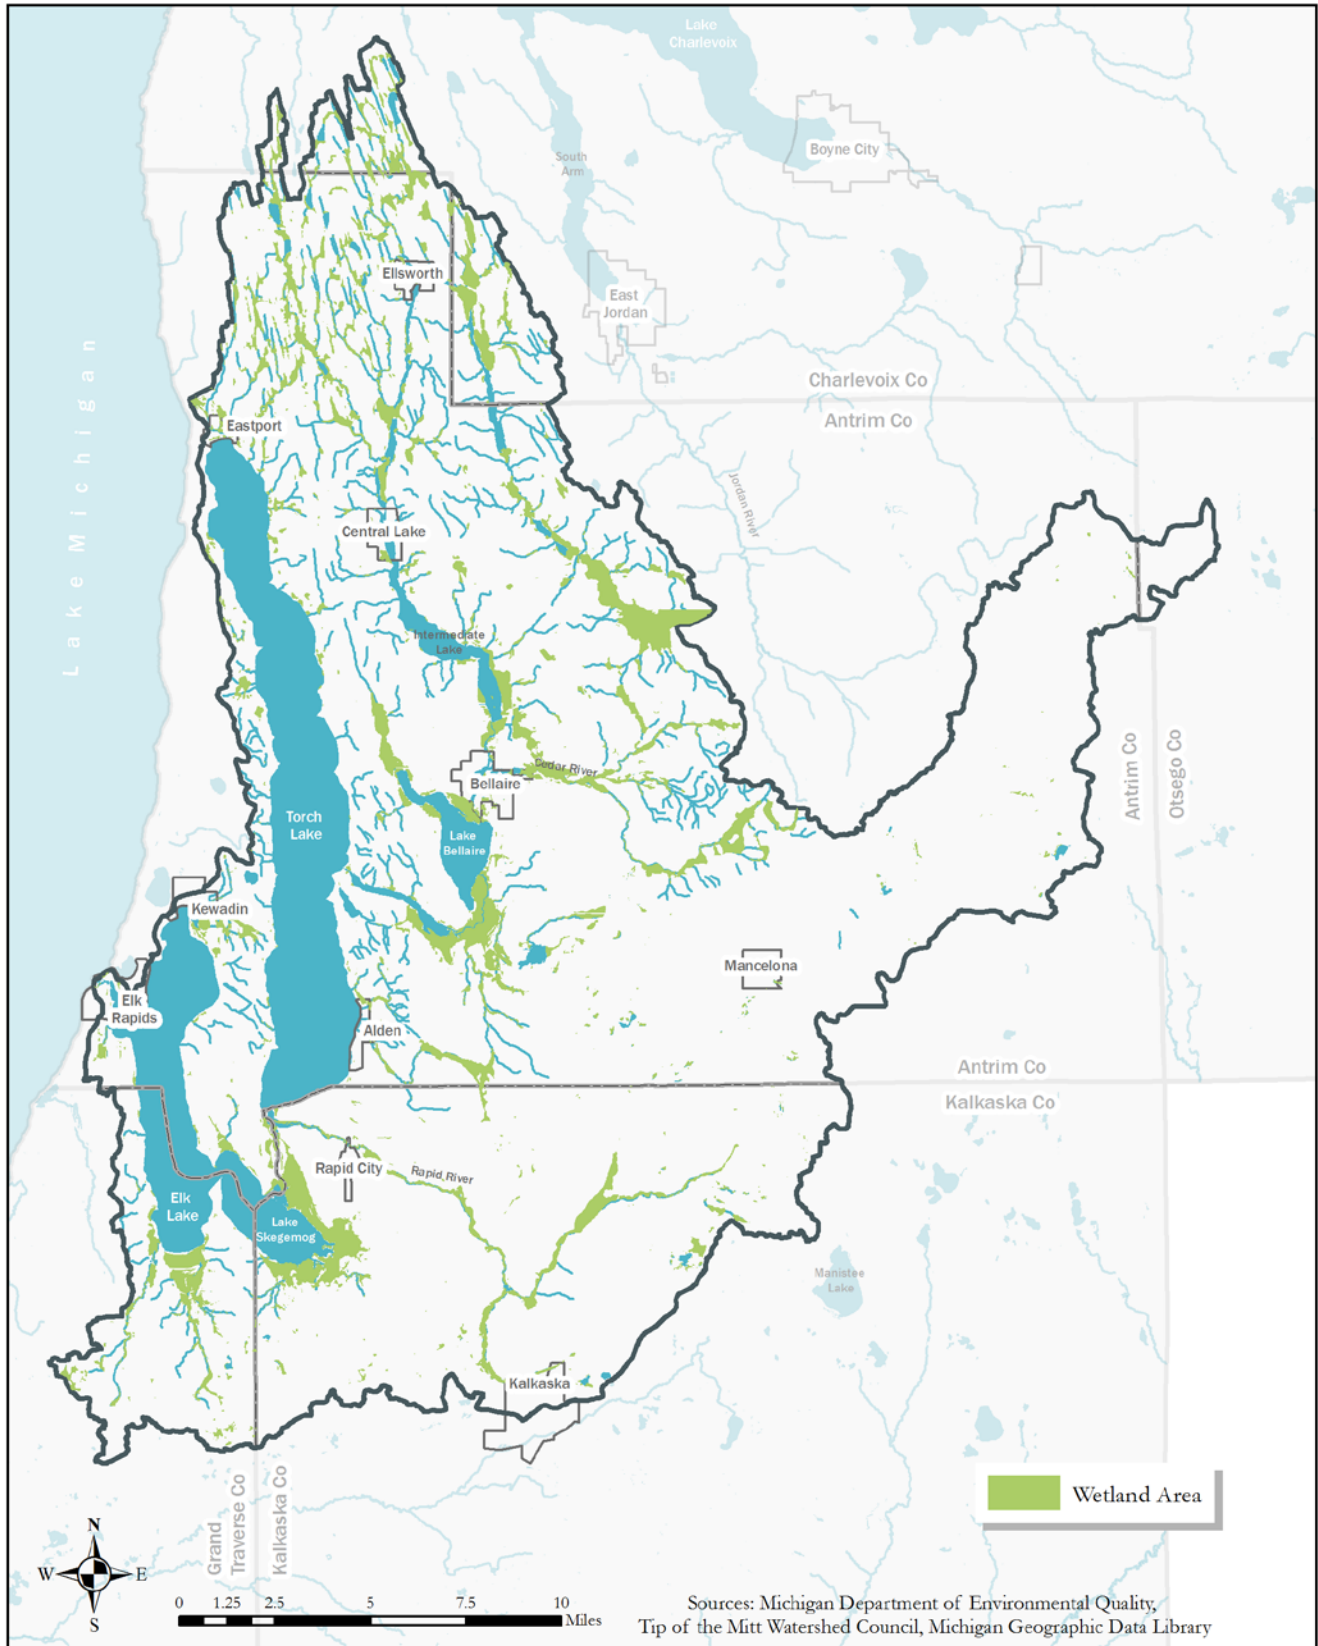
DELINEATED WETLANDS IN THE ELK RIVER CHAIN OF LAKES

Figure 7: The delineated wetlands of the ERCOL watershed.

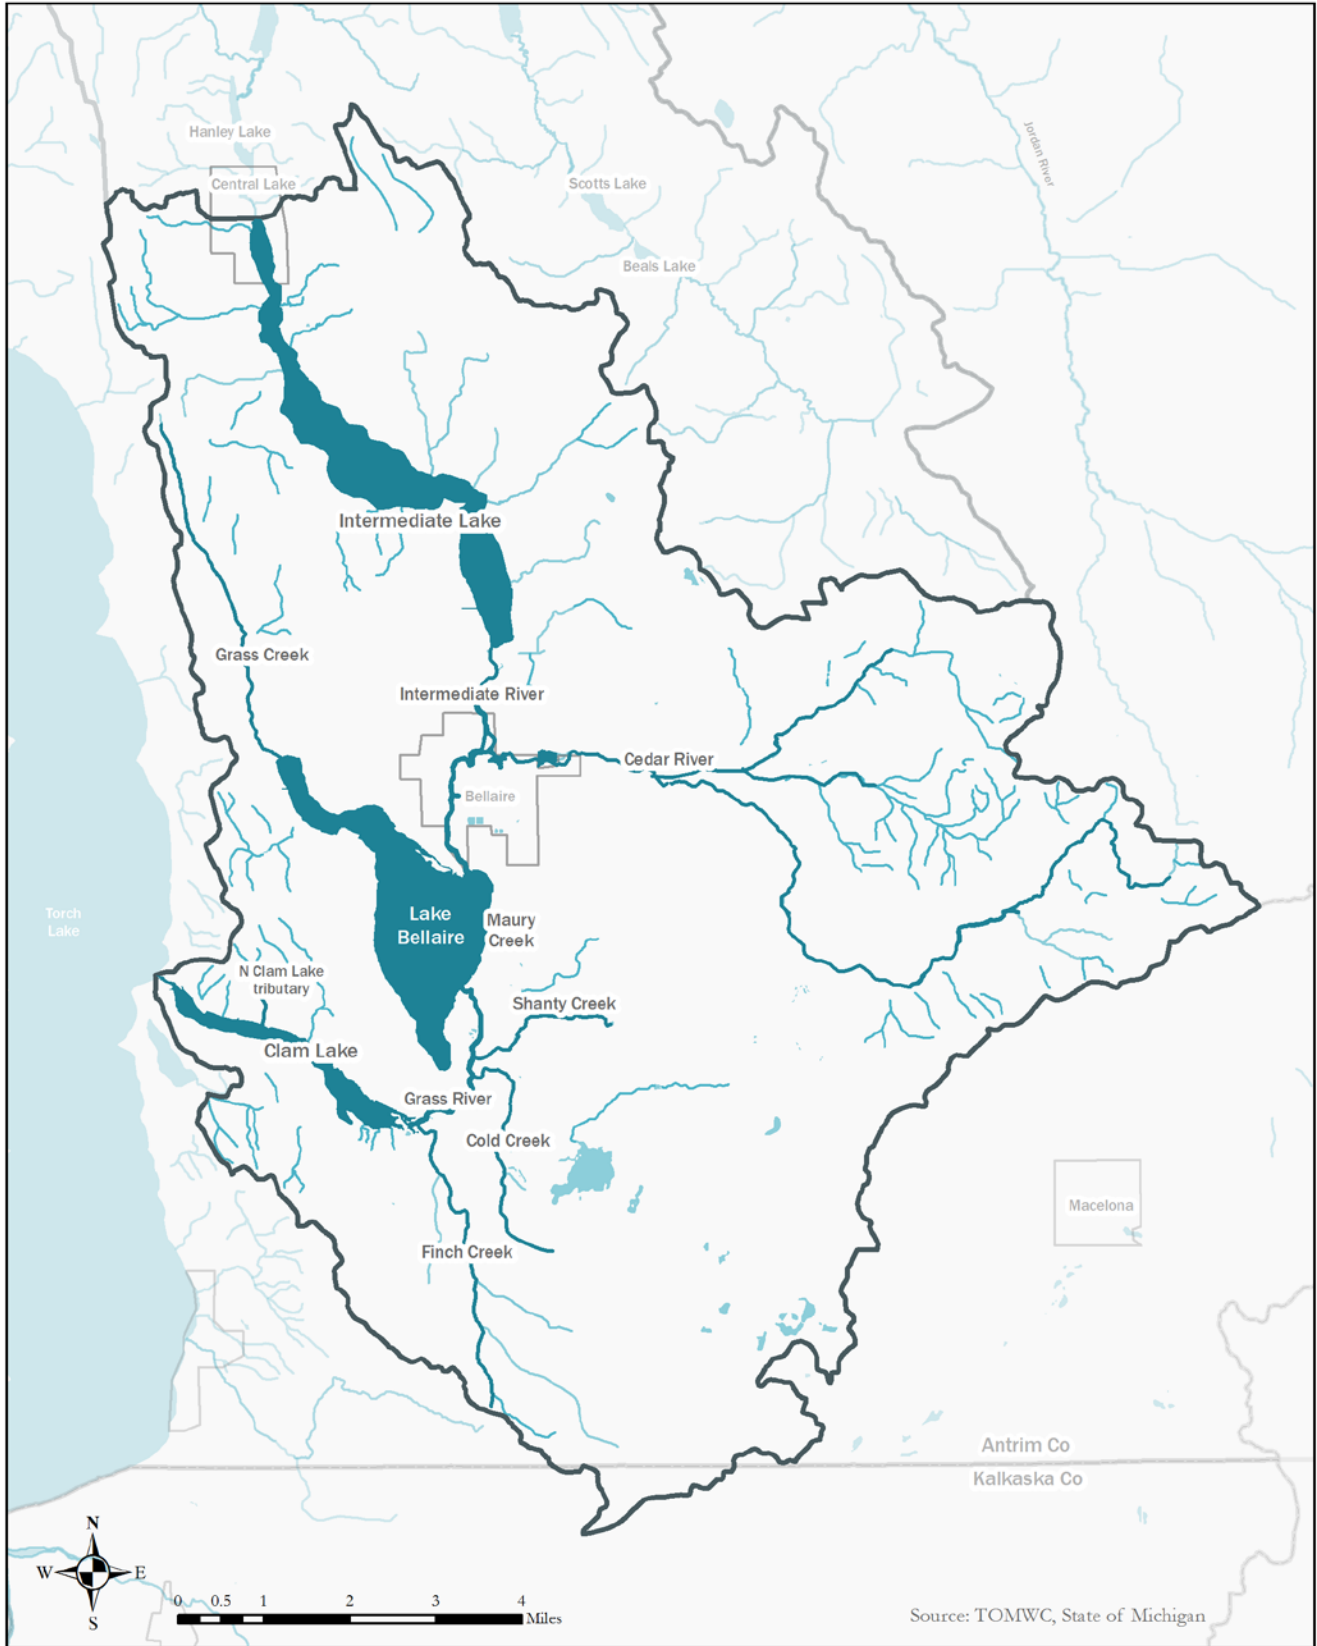
MIDDLE CHAIN: WATER QUALITY SUMMARY (2000 - 2015)

Figure 16: A map of the surface waters within the middle chain region of the ERCOL watershed.
