**ASSESSMENT REPORT
FOR
BAY HARBOR LAKE
BAY HARBOR RESORT
RESORT TOWNSHIP, EMMET COUNTY, MICHIGAN**

BAY HARBOR LAKE ASSESSMENT TEAM

WESTON SOLUTIONS, INC.
2501 Jolly Road, Suite 100
Okemos, Michigan 48864

JUNE 2007

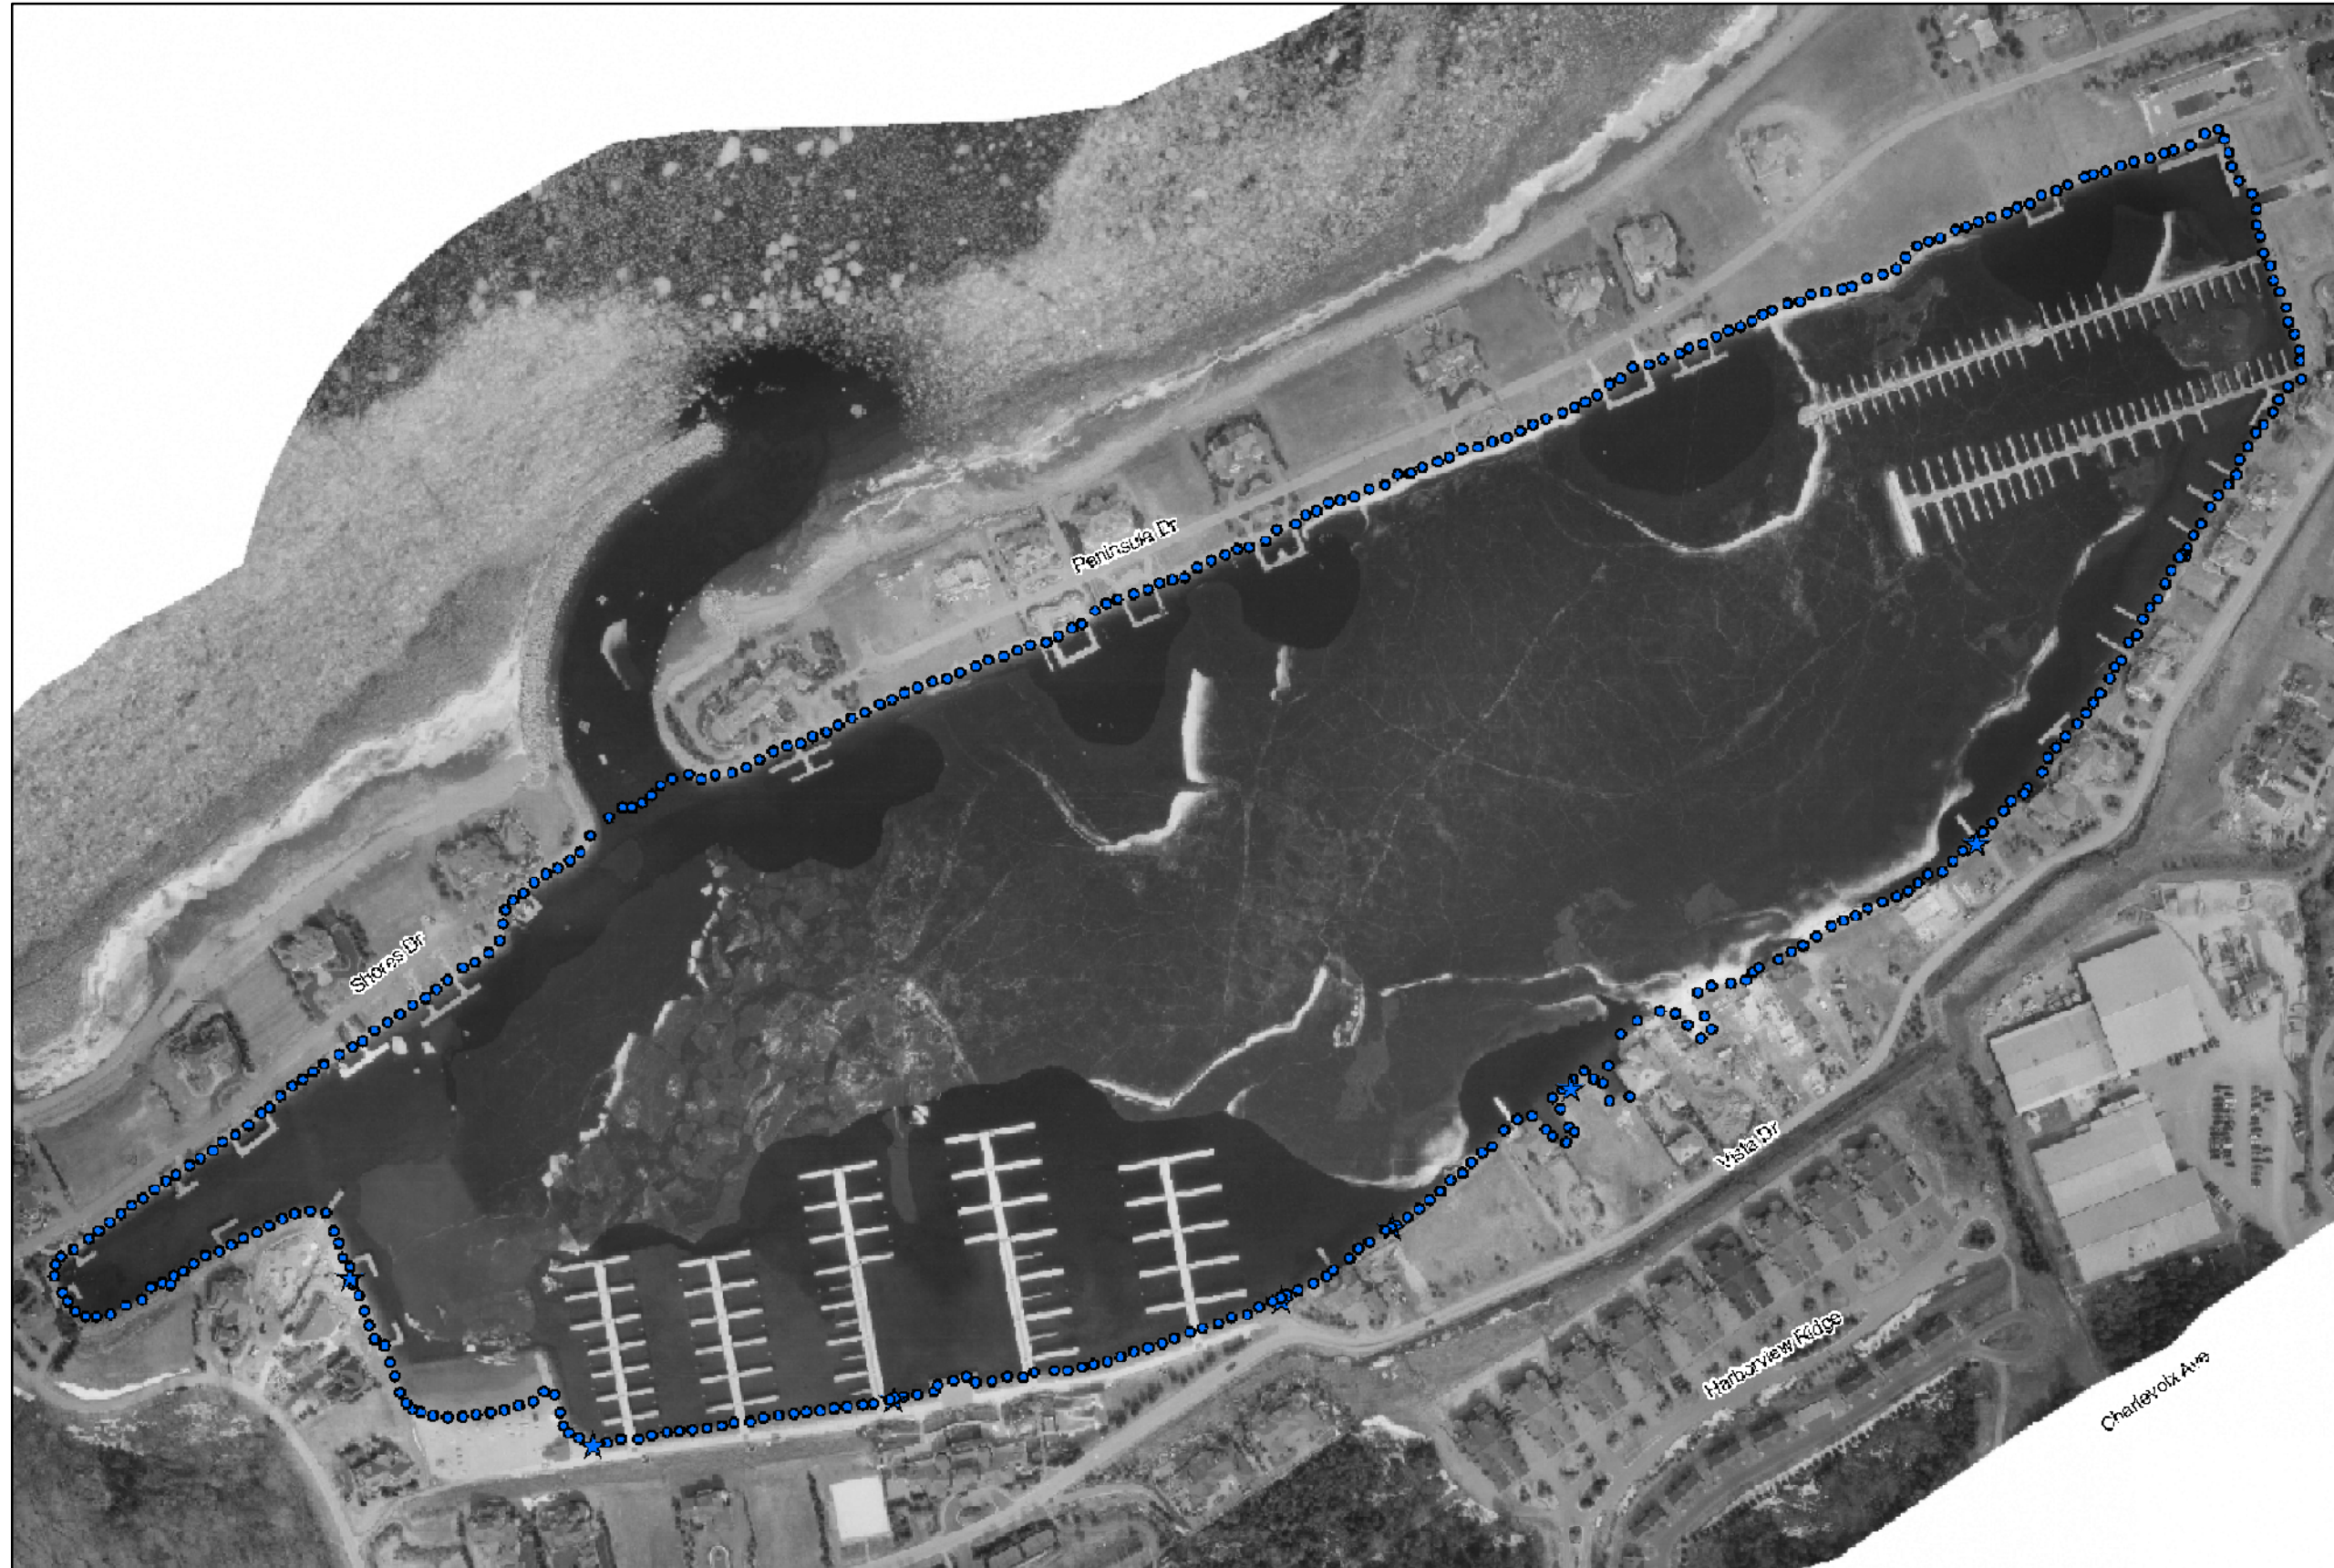
Figure:
2

Bay Harbor Lake pH Monitoring Locations

- pH value less than 9.0
- pH value greater than 9.0
- ★ Outfall Drain location pH value less than 9.0
- ★ Outfall Drain location pH value greater than 9.0

Shoreline Survey
Bay Harbor Lake
May, 2006
Little Traverse Bay CKD Site
Petoskey, Michigan

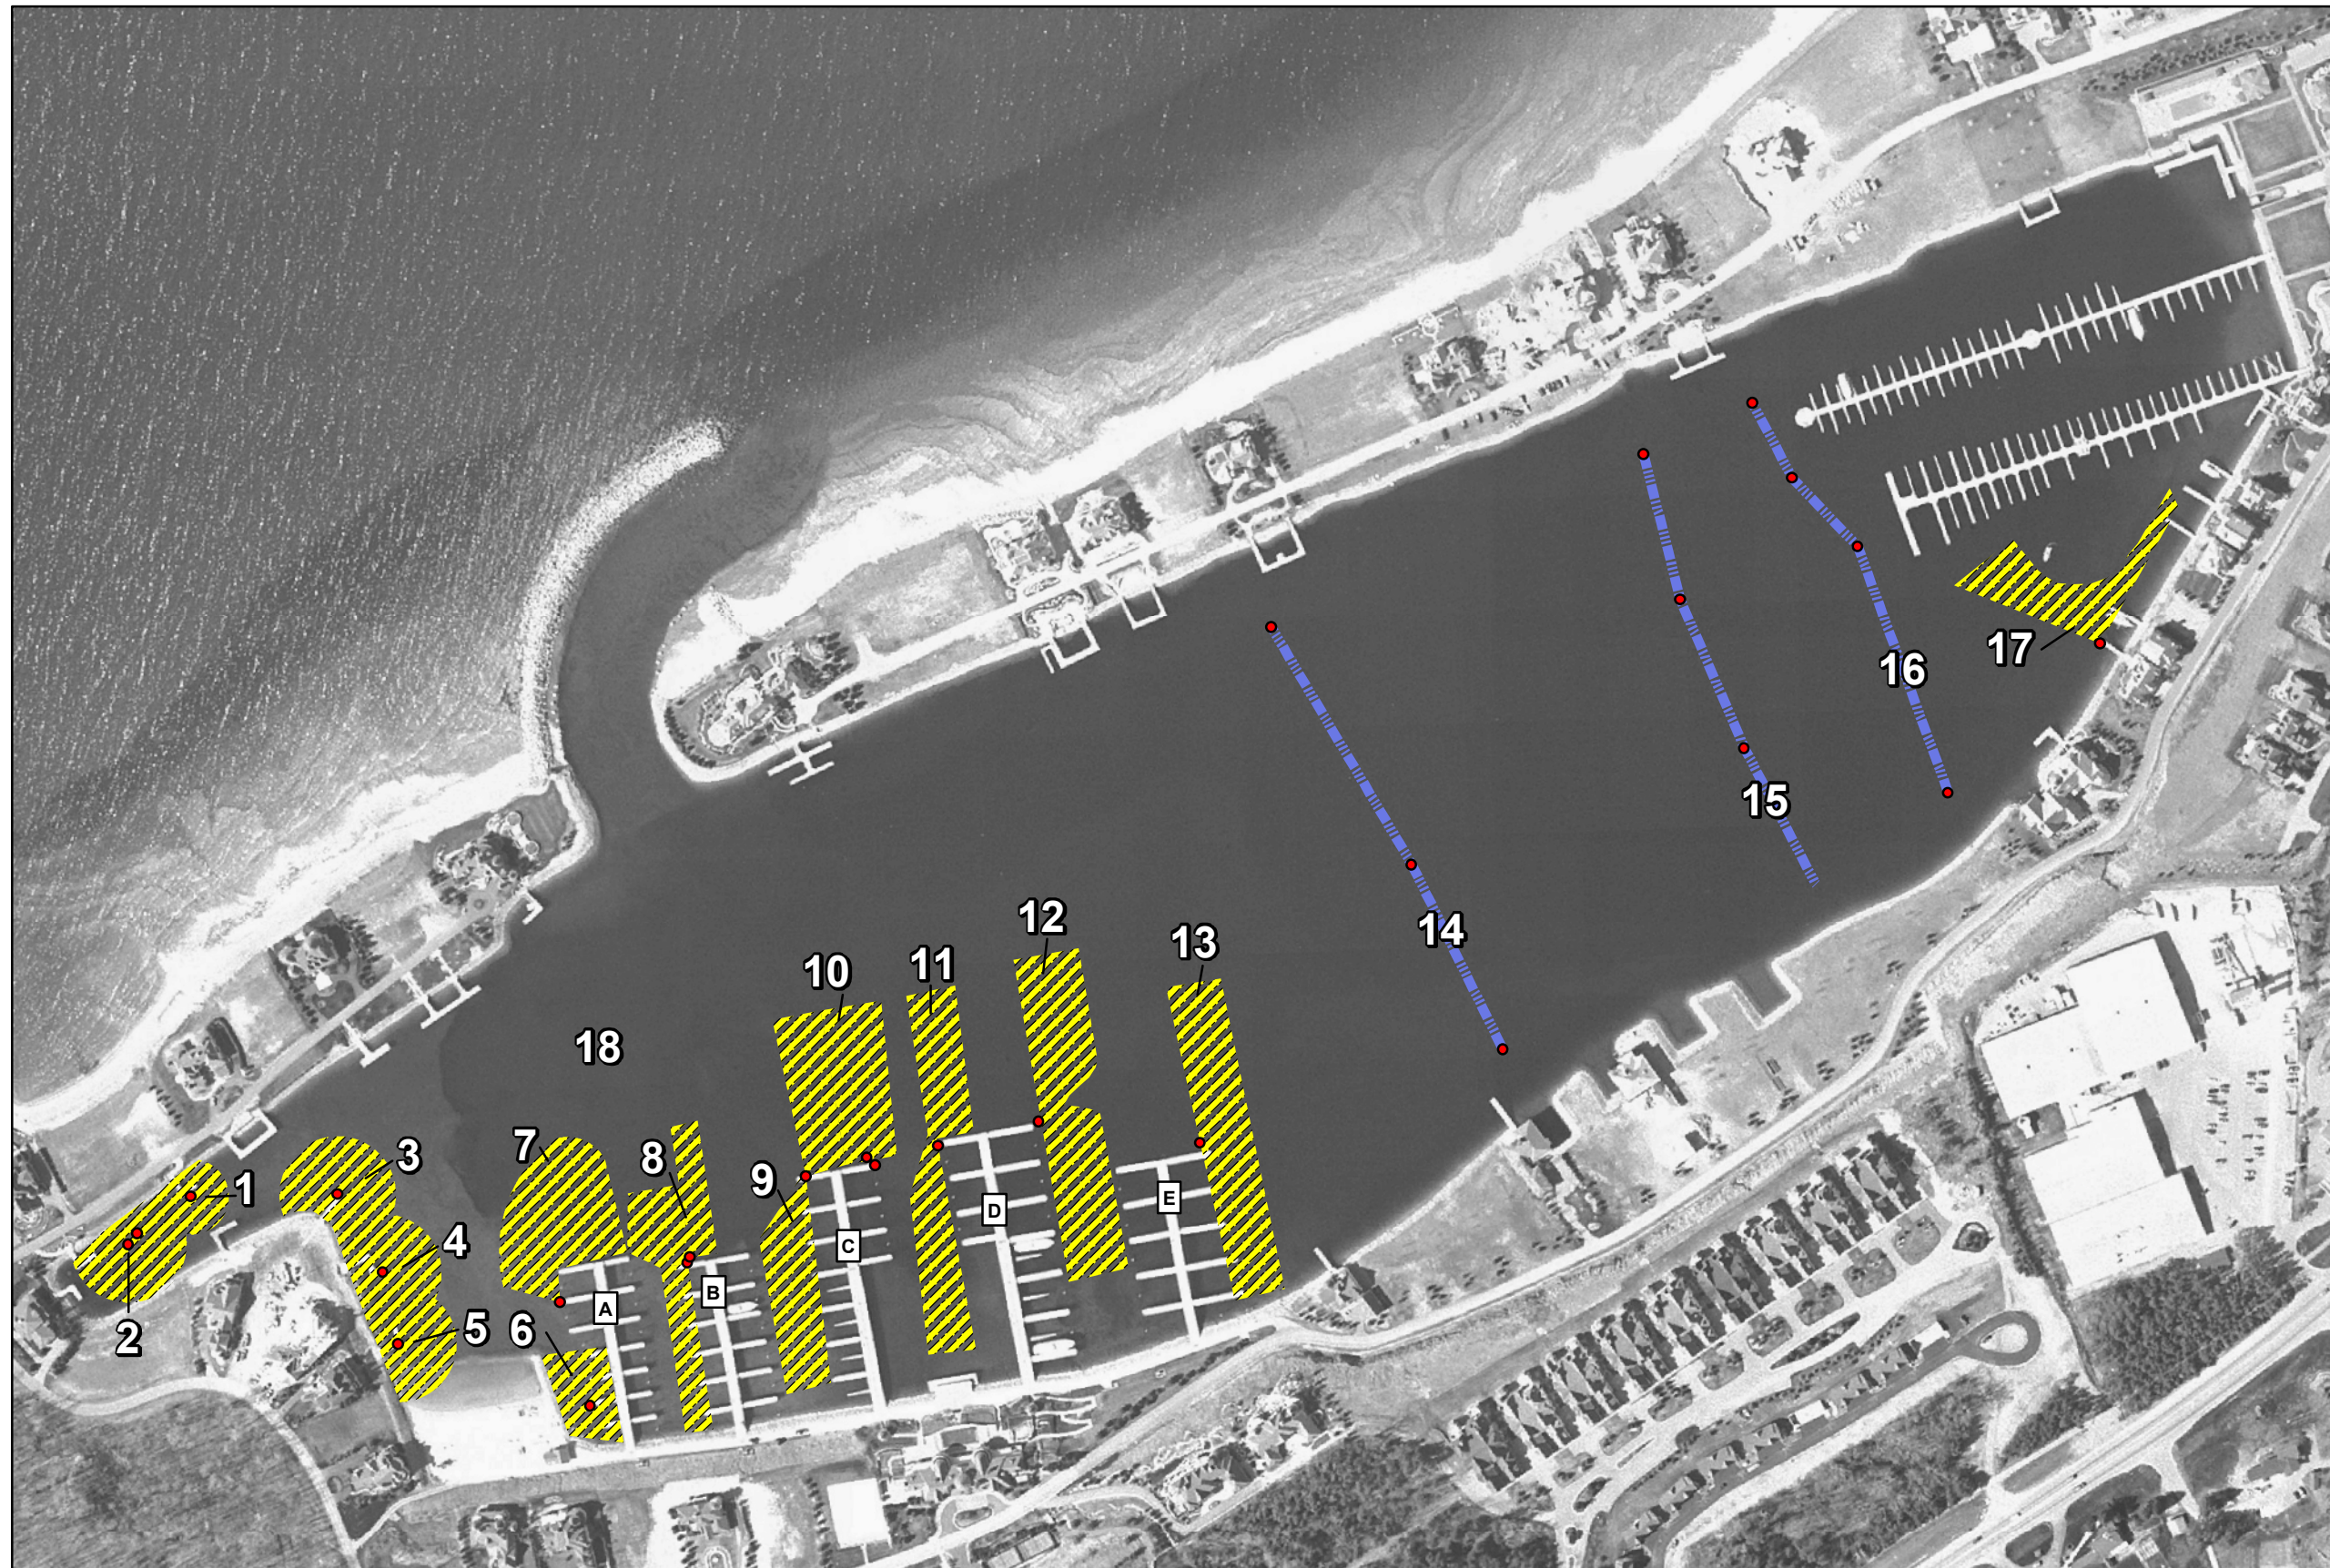
Figure:
4

- GPS Location
- Path of Diver Survey
- Completed With Boat Underway
- Dive Survey Completed From Fixed Point
- 18** Trip Dive Number
- A** Harbor Pier Identifier

Dive Survey
Bay Harbor Lake
June, 2006
Little Traverse Bay CKD Site
Petoskey, Michigan

Fourteen dives totaling 482 minutes were conducted in the vicinity of the Bay Harbor Yacht Club piers (Figure 4 and Table 3, Dives 6-13 and Dive 18; Figure 5 and Table 4, Dives 5-8). The depth in this area ranged from 10 to 41 feet and the visibility was typically greater than 25 feet. The area between the piers is relatively flat with a uniform bottom, and the deeper areas were found near the central and eastern piers (Piers C, D, and E). The bottom consists of a 2- to 6-inch layer of silty sand over a hard packed gravel and rock substrate with an occasional gravel to softball-sized piece of rock or construction debris. As observed in the western area, small patches of disturbed and discolored sediment caused by the feeding activity of fish were noted throughout this area. In the central portion of the pier area, a forested patch remains and remnants of rooted trees rise 20 feet or more above the lake bottom.

In June, one dive totaling 36 minutes (Figure 4 and Table 3, Dive 17) was conducted around the floating dock area in the western portion of Bay Harbor Lake. This area was not surveyed during the October deployment. Although the maximum depth noted was 66 feet, the typical lake depth in the dock area was 30 feet or less. The bottom in this area was flat with little relief. The visibility was less than 25 feet because the sky was heavily overcast with light rain so there was less available light than during other dives. The sediment consisted of a ½- to 1-inch layer of silty sand over a hard packed gravel and rock substrate. The color of the sediment was light tan to brown and the bottom was flat and featureless. The rock and other structures throughout the area were covered with a thick biofilm and inorganic sediment.

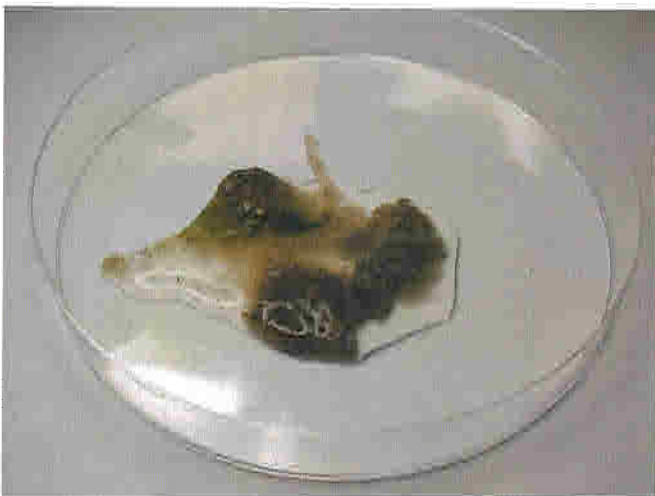
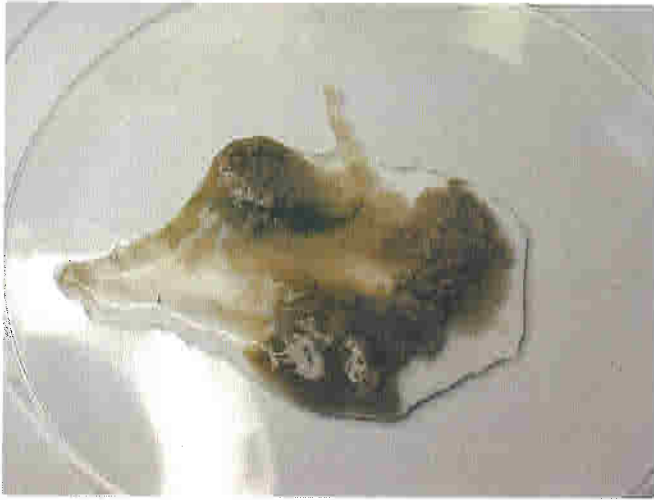
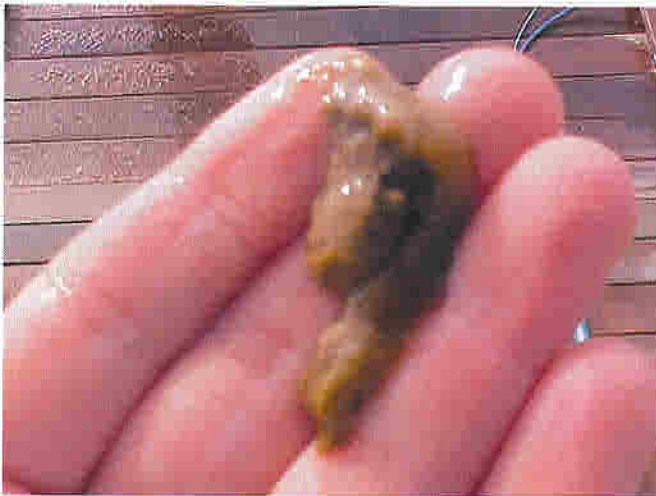
Figures 1 and 2 identify the appearance of the greenish-brown slimy material in the base of the petri dish. In comparison, Figure 3 presents an image of the same material recovered from bottom debris at Bay Harbor Lake immediately following sample collection. As an environmental microbiologist, it is my opinion that the sample received at the laboratory is very similar in color and structure to that shown on Figure 3. Digital images of the sample taken at the laboratory were obtained with a Nikon Coolpix 4500 camera.

Figure 1. Macroscopic image of gelatinous, slimy material in petri plate (Bay Harbor Lake sample, March 2006).

Figure 2. Macroscopic image of gelatinous, slimy material, close up (Bay Harbor Lake sample, March 2006).

Figure 3. Macroscopic image of gelatinous, slimy material as observed immediately following sampling (Bay Harbor Lake sample, March 2006).

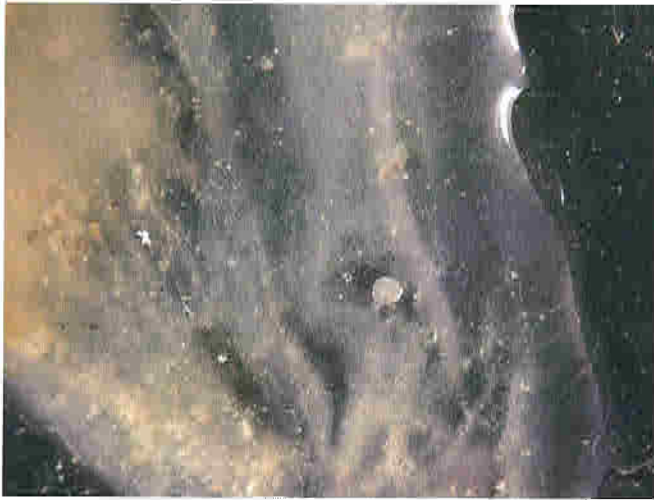
Following initial observation of the sample in the petri plate, the digital camera was fitted to a Nikon SMZ-1B stereomicroscope for examination at 8 to 35 × magnifications. Figure 4 shows the gelatinous, slimy material as it separates from the algal growth. Figure 5 shows that the gelatinous, slimy material is composed of a water mold. The large opaque spherical object to the right of the image is the sexual form of the mold. *Allomyces* can produce gametangia (sex cells) that appear very similar to what is observed in the sample.

Figure 4. Image of sample as observed with the stereomicroscope and black background at 8 × magnification (Bay Harbor Lake sample, March 2006)

Figure 5. Image of sample as observed with the stereomicroscope and black background at 35 × magnification (Bay Harbor Lake sample, March 2006).

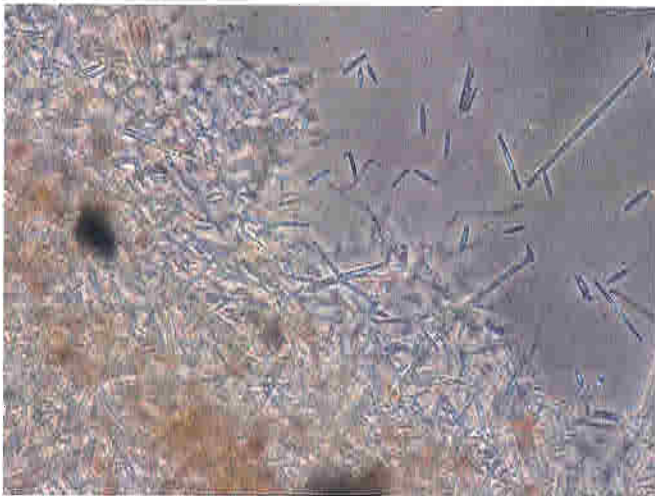
Figures 6, 7, and 8 show the hyphae of the water mold with the green algae filaments and the diatoms amongst the gelatinous material at a magnification of 400 ×. Further examination at 1000 × magnification shows the water mold hyphae.

Figure 6. Microscopic image using phase contrast microscopy at 400 × magnification (Bay Harbor Lake sample, March 2006).

Figure 7. Microscopic image of diatoms using phase contrast microscopy at 400 × magnification (Bay Harbor Lake sample, March 2006).

Figure 8. Microscopic image of water mold filaments (hyphae), diatoms and algae as observed at 400 × magnification (Bay Harbor Lake sample, March 2006).

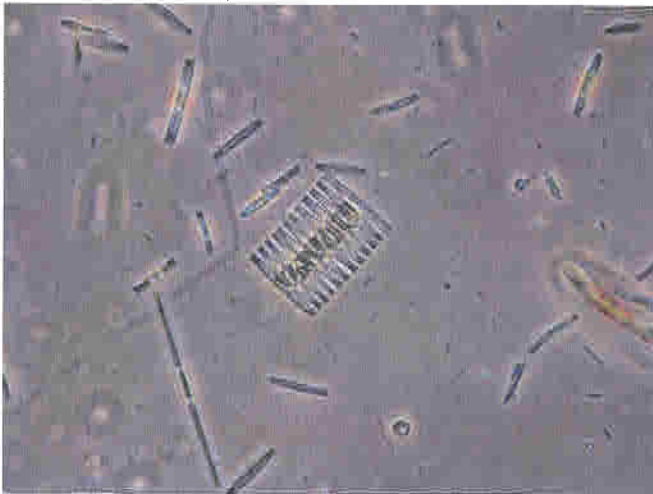
Figure 9 shows the predominant diatoms in the sample at 1000 × magnification. Figure 10 again shows the gelatinous, slimy mass of hyphae of the water mold observed growing on the stones, pebbles, etc. on the bottom of Bay Harbor Lake.

Figure 9. Microscopic image of diatoms as observed at 1000 × magnification (Bay Harbor Lake sample, March 2006).

Figure 10. Microscopic image of the water mold hyphae as observed at 1000 × magnification (Bay Harbor Lake sample, March 2006).

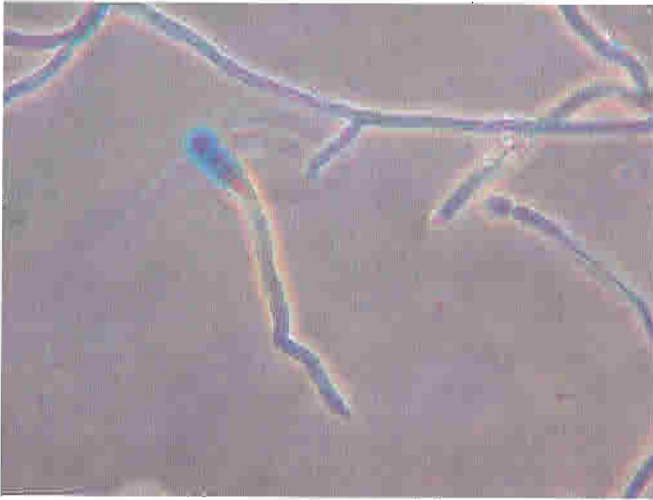
Figure 11 shows a microscopic image of the hyphae, which are long filaments of a mold that grows over the surface to which the mold is attached. Figure 12 shows the conidia under phase contrast microscopy at 400 × magnification. Conidia are asexual nucleate spores that are produced at the ends of the hyphae and are released into the environment.

Figure 11. Hyphae of *Alternaria* sp. as observed at 400 × magnification (recovered from Bay Harbor Lake sample, March 2006 and grown in sterilized Lake Huron water).

Figure 12. Hyphae and conidia of *Alternaria* sp. as observed at 400 × magnification (recovered from Bay Harbor Lake sample, March 2006 and grown in sterilized Lake Huron water).

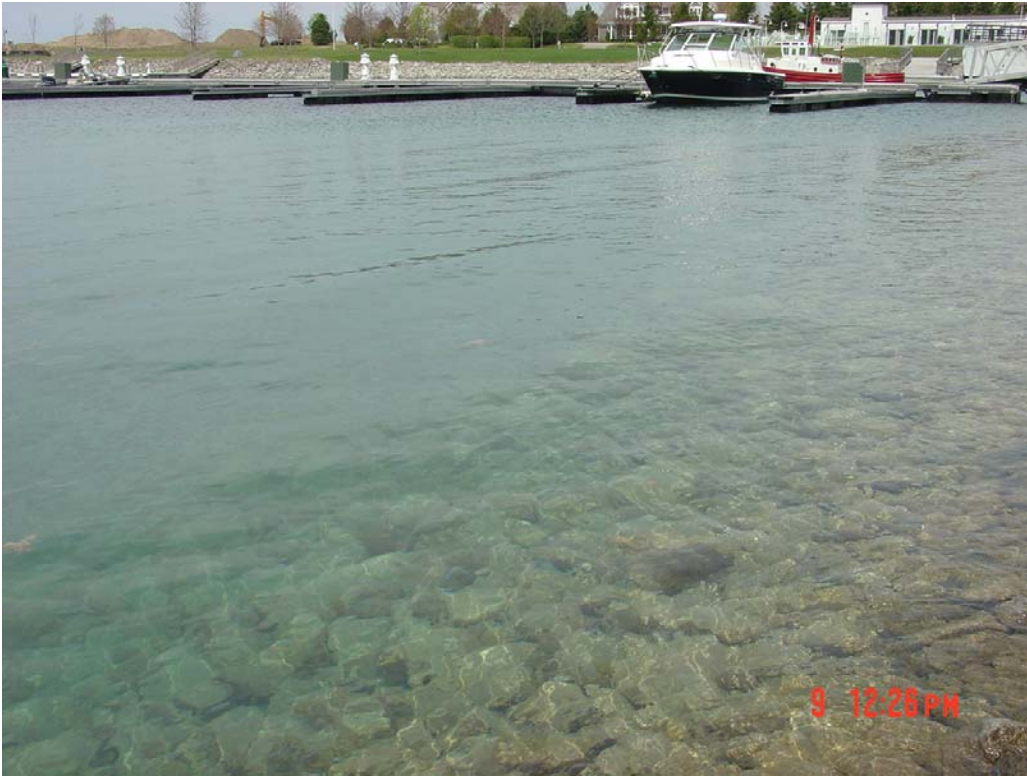
Photo Description: Shoreline conditions observed during May 2006 Shoreline Survey.

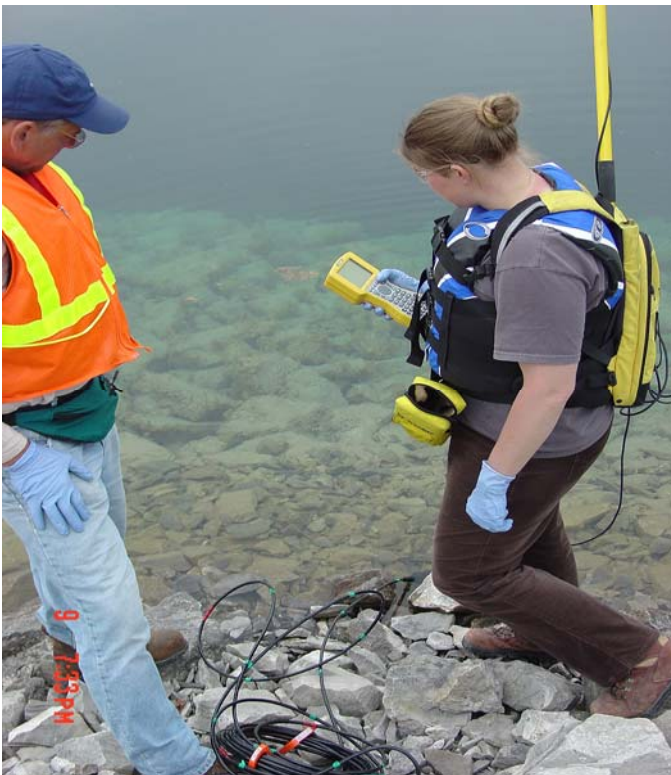
Photo Description: Barr and U.S. EPA START contractor personnel collecting shoreline water quality measurements – May 2006

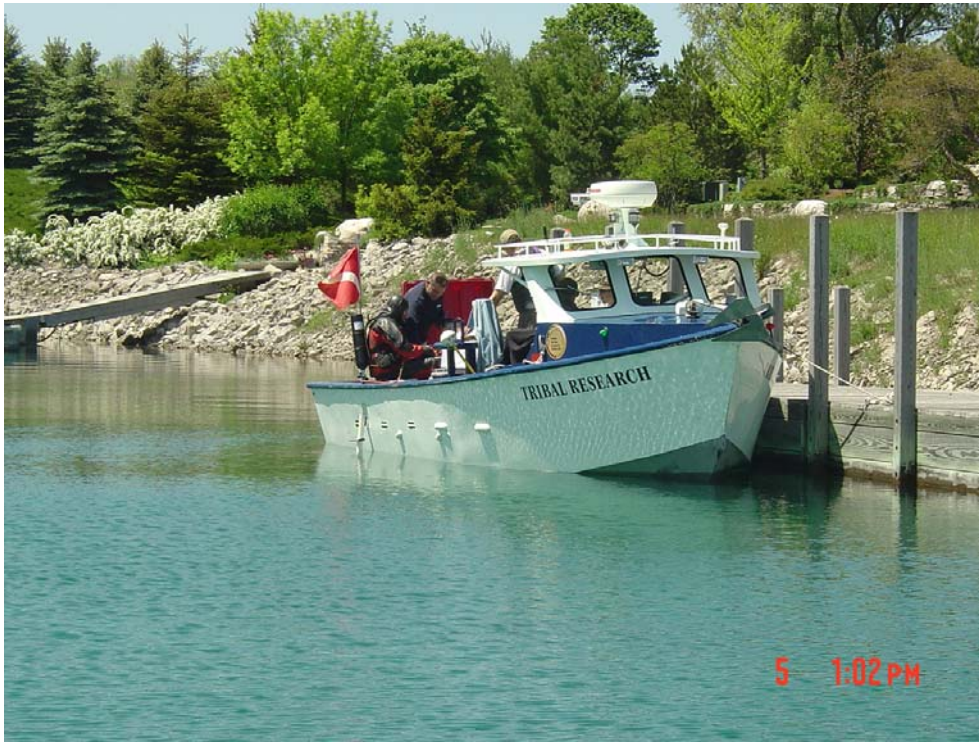
Photo Description: Dive support boat utilized during Bay Harbor Lake Dive Survey – June 2006

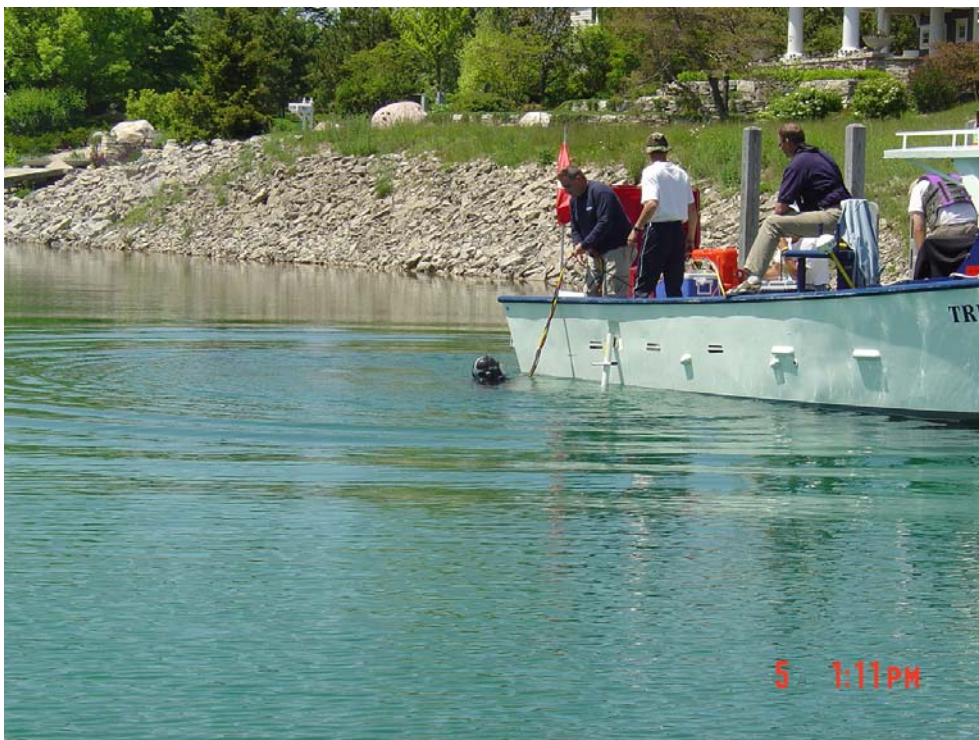
Photo Description: U.S. EPA Environmental Response Team (ERT) diver entering the water to commence visual and water quality monitoring survey – June 2006

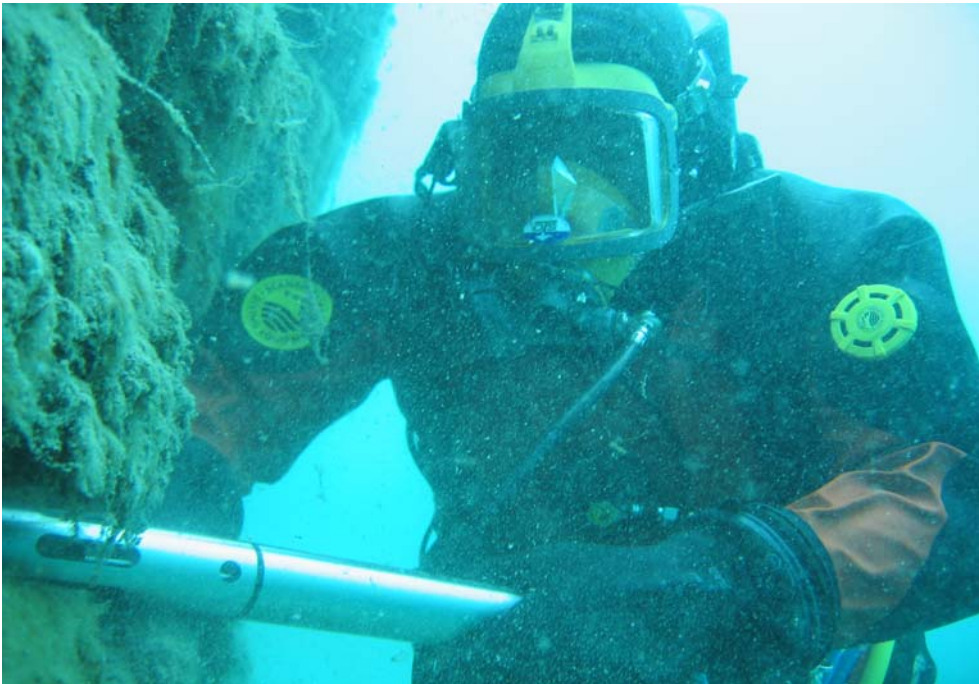
Photo Description: ERT diver conducting water quality monitoring with YSI probe in Bay Harbor Lake – June 2006.

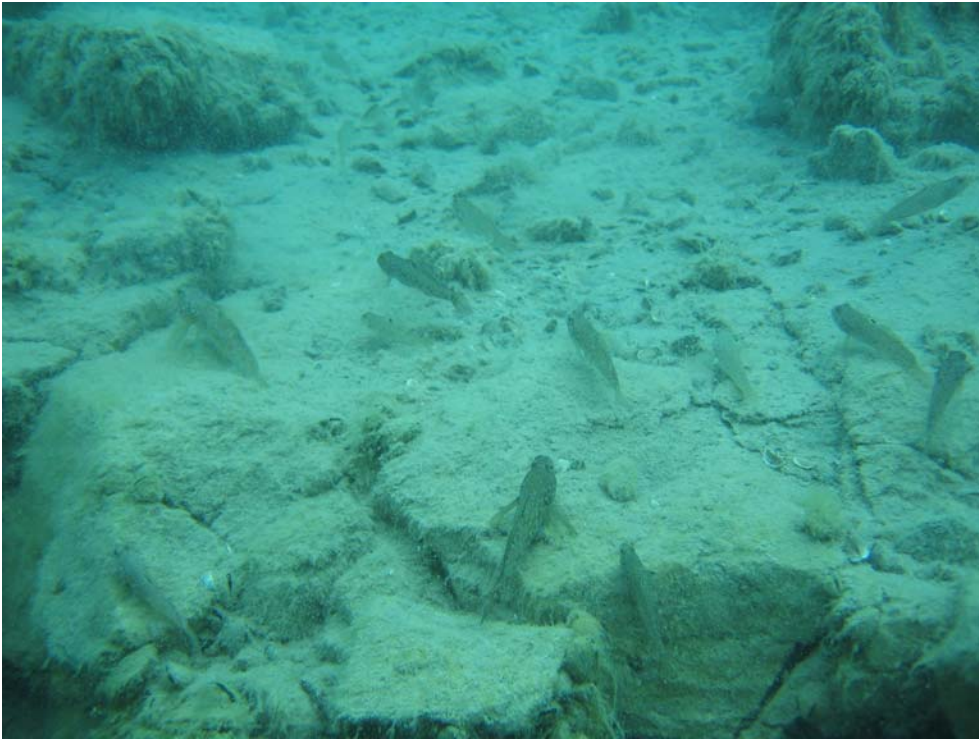
Photo Description: Observation along bottom of Bay Harbor Lake – June 2006.

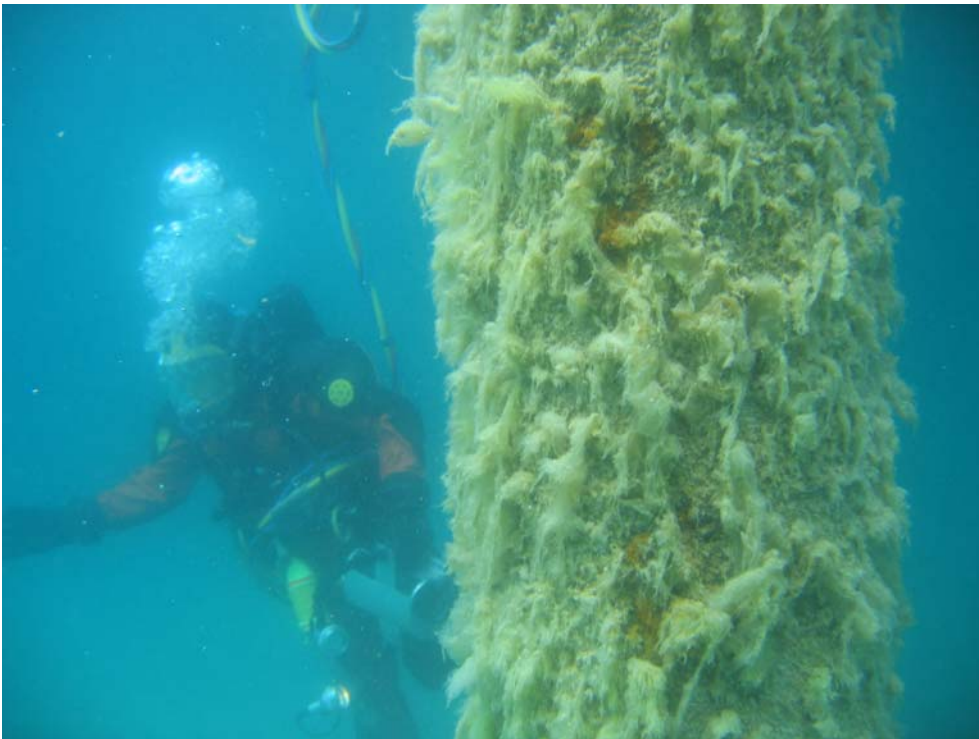
Photo Description: ERT diver conducting visual and water quality monitoring near dock pier in Bay Harbor Lake – June 2006

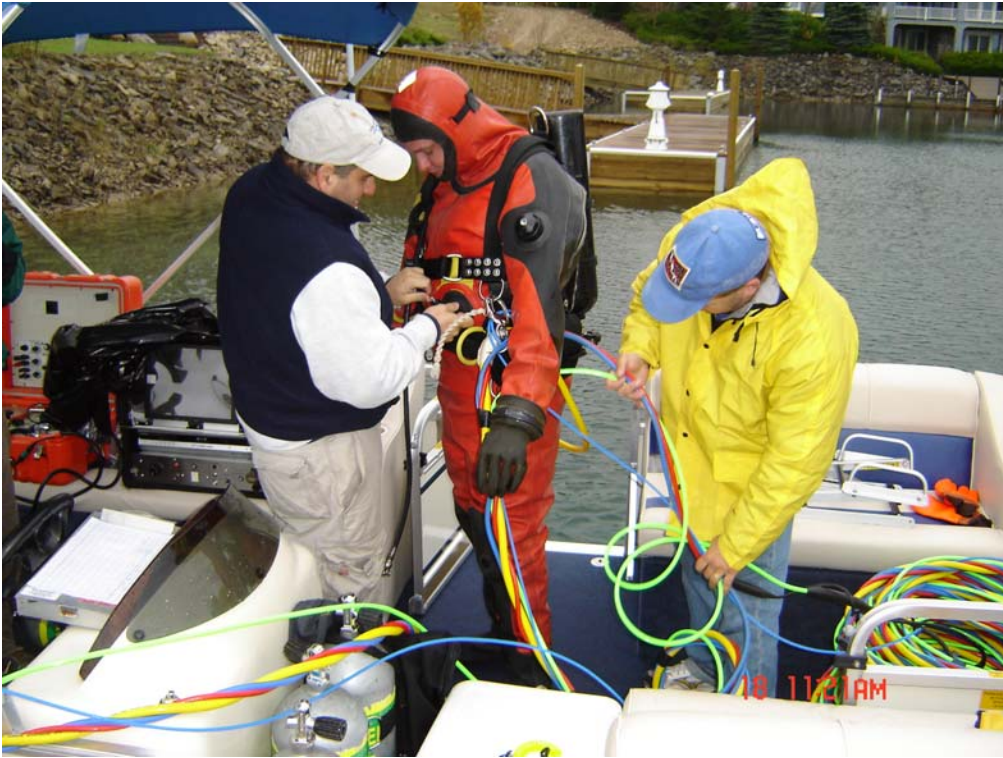
Photo Description: ERT diver preparing to conduct second round of dive survey – October 2006

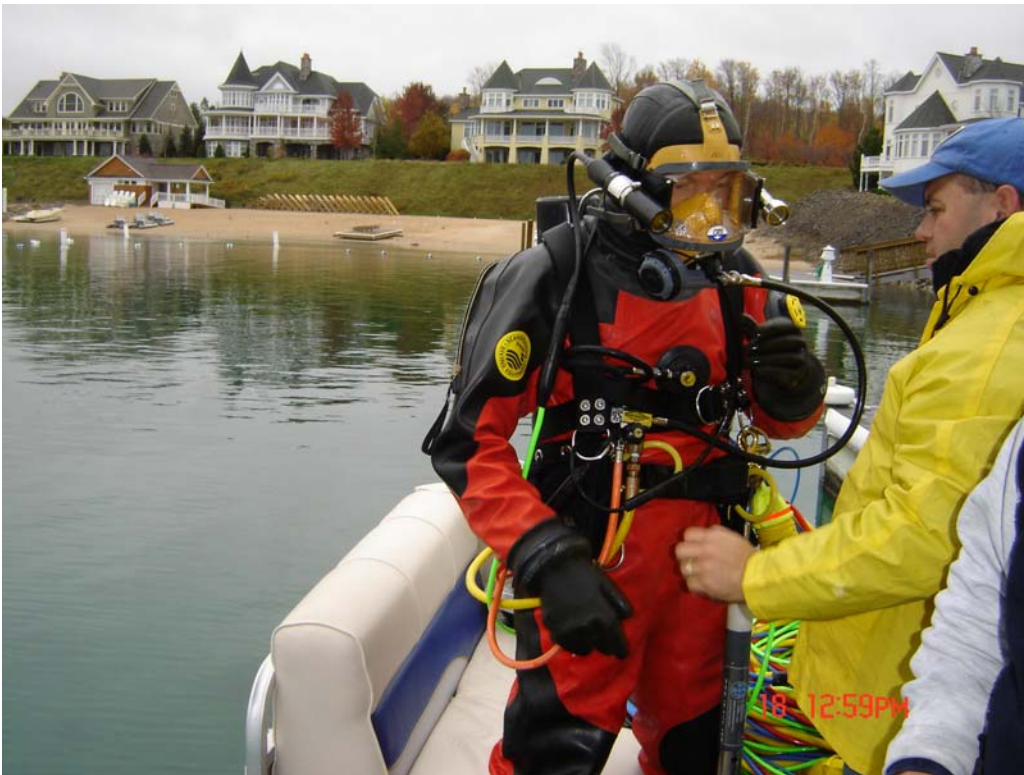
Photo Description: ERT diver preparing to enter water to commence collection of water quality monitoring data – October 2006

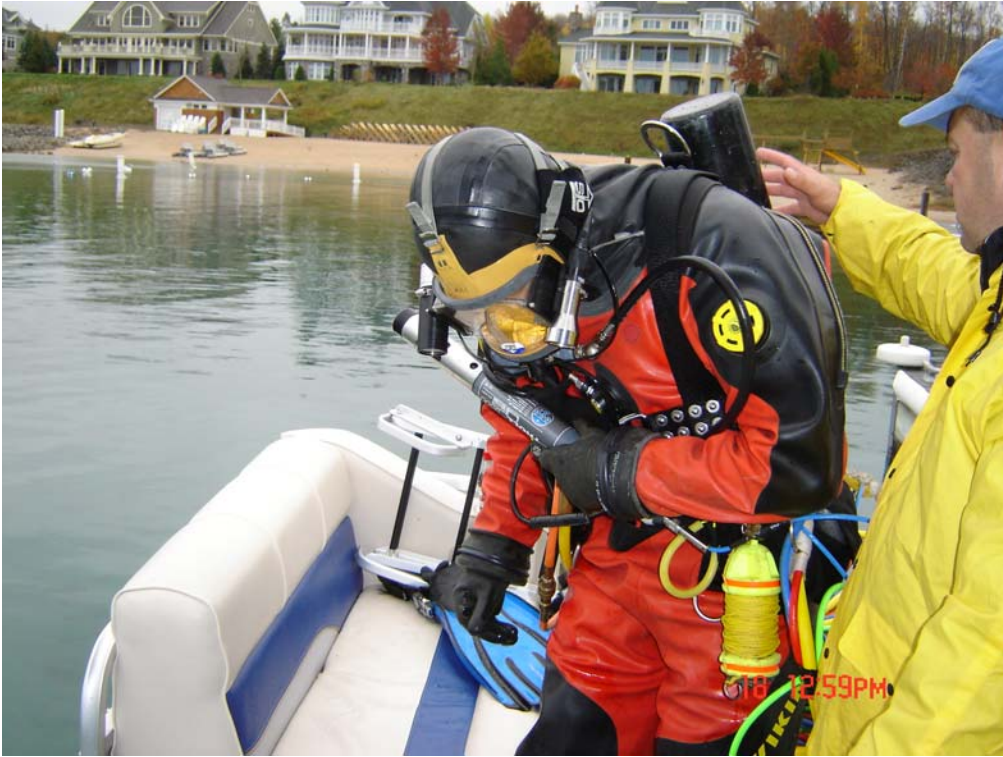
Photo Description: ERT diver with Troll 9000 monitoring probe utilized to collect pH and conductivity measurements – October 2006

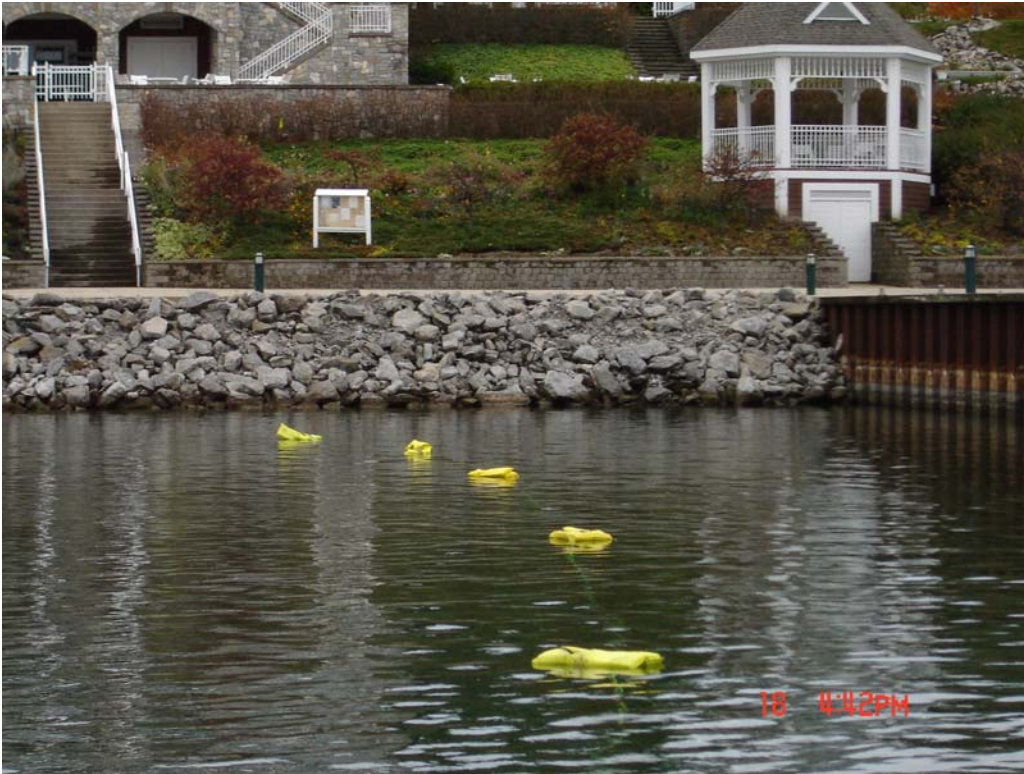
Photo Description: Buoys marking dive transect from Bay Harbor Lake shoreline – October 2006
