U.S. Fish & Wildlife Service - Midwest Region

Preliminary Results of Fish-Barge Interactions at the Electric Dispersal Barrier in the Chicago Sanitary and Ship Canal

December 2013

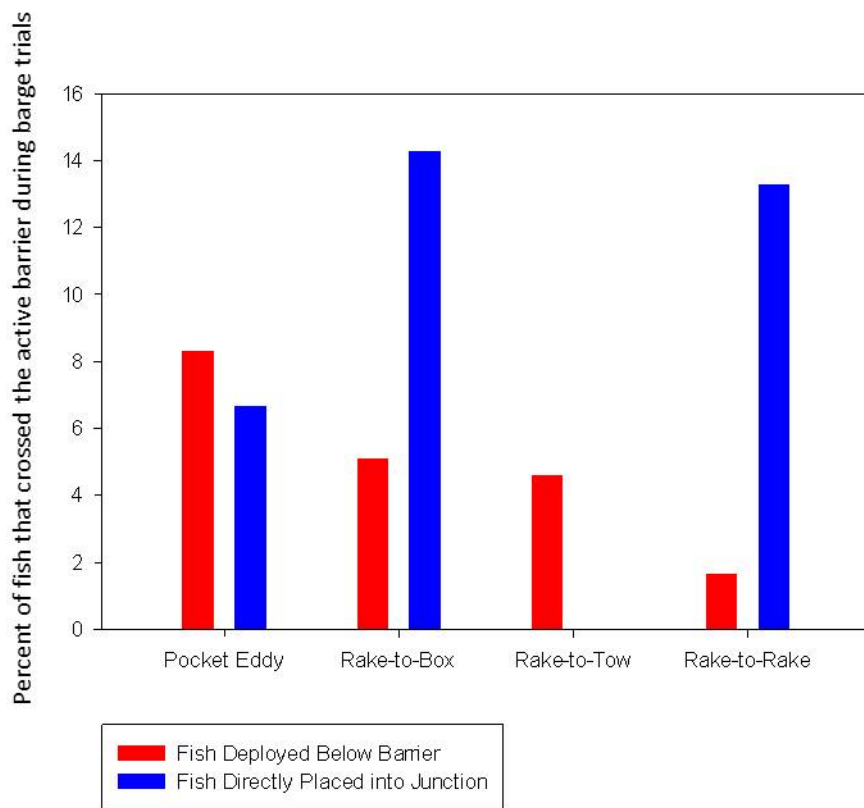
Figure 3. Percentages of live tethered fish that crossed the barrier system via different barge junction configurations and fish deployment methodologies.

During the unconfined, tethered fish trials, the results varied depending on fish deployment method used and the barge configuration (Figure 3). All barge configurations evaluated yielded some percentage of entrainment beyond the barriers, except for rake-to-tow, when fish were directly placed in that junction wedge. The 41 Gizzard Shad entrained beyond the barriers ranged in size from 9.9 – 24.7 cm TL. Instances of entrainment beyond the barrier occurred both after direct placement into a junction wedge or deployment below the barrier. Of the 340 Gizzard Shad used during the tethered fish evaluations, 21 crossed after direct placement into a junction wedge whereas 20 crossed after deployment below the barrier. (Note: measurements were not made on all fish that crossed the barrier. In three cases, tethered fish were observed beyond the barrier but were able to elude recapture by field personnel. In these cases, only the location coordinates were recorded where they were observed.)

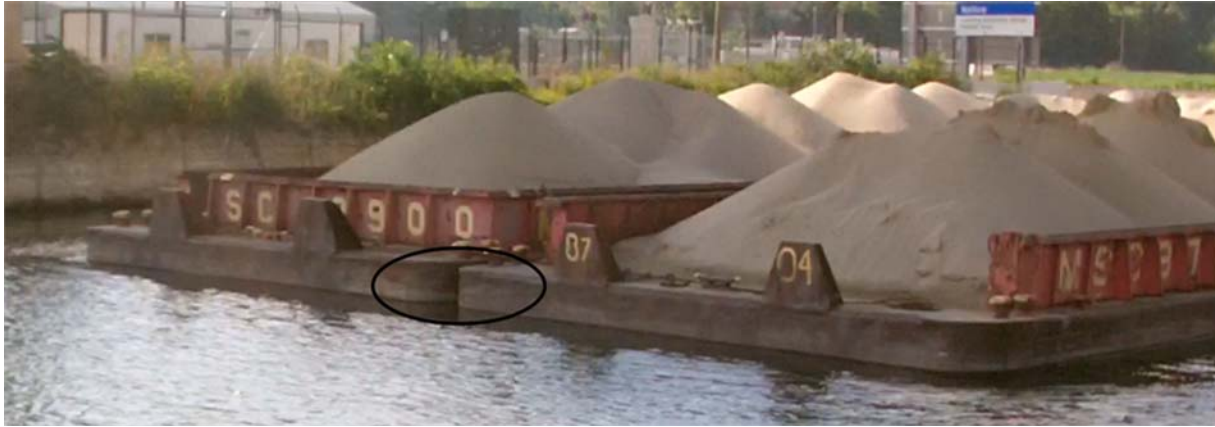
Figure 4. Picture of the front of a rake-to-rake barge configuration traversing the electrical barrier with the square ends in the front. The circle denotes the small void space that two live fish swam into and remained inside beyond the barrier.

We were able to perform nine trials using unconventional modes of barge navigation in order to investigate possible modes of transportation to reduce the possibility of fish entrainment. Twenty fish were deployed in front of the rake-to-rake configuration as the barges were pulled upstream by the tow vessel. None of the fish were entrained beyond the barrier; however, that method of transport will most likely not be a feasible alternative for commercial navigation traversing the barrier. The first trial run, which consisted of the barges moving through the entire barrier system, took over an hour to complete (as opposed to a normal passage time of around five minutes). This was because the current in the canal, as well as the propeller jet from the tow vessel flowing against the boxed ends of the barges created more drag. The second run had to be prematurely interrupted after the tow vessel stalled several times and could no longer pull the barges forward. Three trial runs were performed in which the barge vessel ceased movement for two minutes prior to entering the barrier. Of the 30 fish that were used, 3 of them remained within the rake-to-box junction wedge for the entire two minutes, and were then entrained beyond the barrier. Four trials were performed in which the barge alternated approach angles in a zig-zag pattern across the barrier. Of the 40 fish that were used, 6 of those fish remained within the rake-to-box junction wedge and were entrained beyond the barrier. We were able to observe some of these fish swimming within the junction wedge either as it was moving or when the barge stopped, indicating that the fish remained within the rake-to-box junction on their own volition (as opposed to involuntarily after being incapacitated). The sizes of the Gizzard Shad that crossed the barrier during our unconventional navigation approaches ranged from 21 – 26.5 cm total length.
