Enbridge Mackinac Straits ILI Review

NPS 20 Pipeline
Enbridge Line 5;
East and West Mackinac Straits

Report May 12, 2016

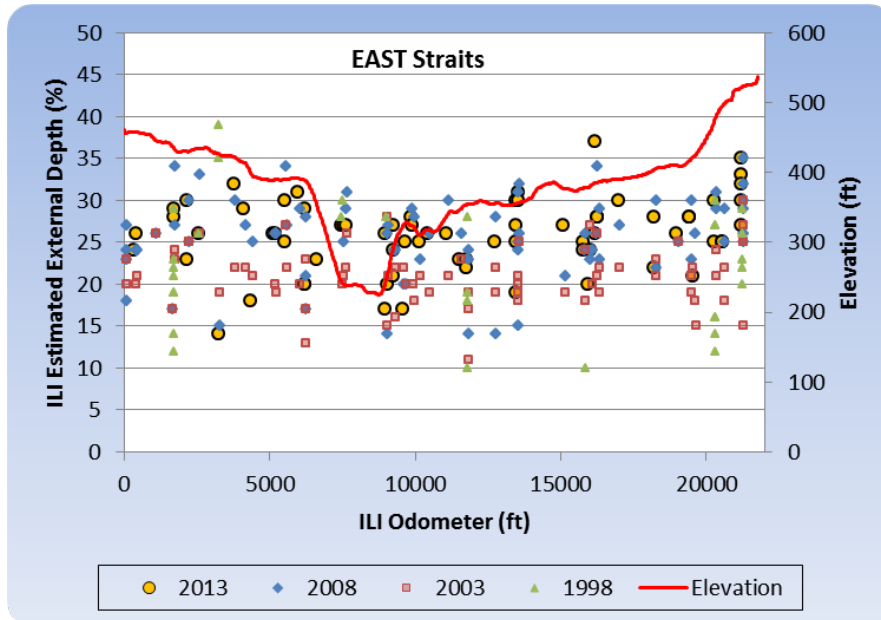
Figure 1. Distribution of external metal loss anomalies in the East Straits.

Note that the older 1998 MFL technology detailed many fewer metal loss features than the more recent technologies. The average lengths are greater in the 2013 inspection than in 1998, verifying that the quantity of anomalies is not a result of interaction method variations. The quantities of anomalies are similar in the 2003, 2008 and 2013 inspections. The locations of higher densities of anomalies tend to agree between inspections. Also, there are a few discrepancies between metal loss being called either internal or external in the MFL inspections. Generally, this is typical and not of great concern as the remaining strength is not governed by the side of pipe the metal loss is on and the interaction of anomalies should not depend on this either. Many locations of higher density internal metal loss are at local low

elevation areas. This implies that there may have been corrosion at some point in time, particularly when there is more than one pipe joint included.

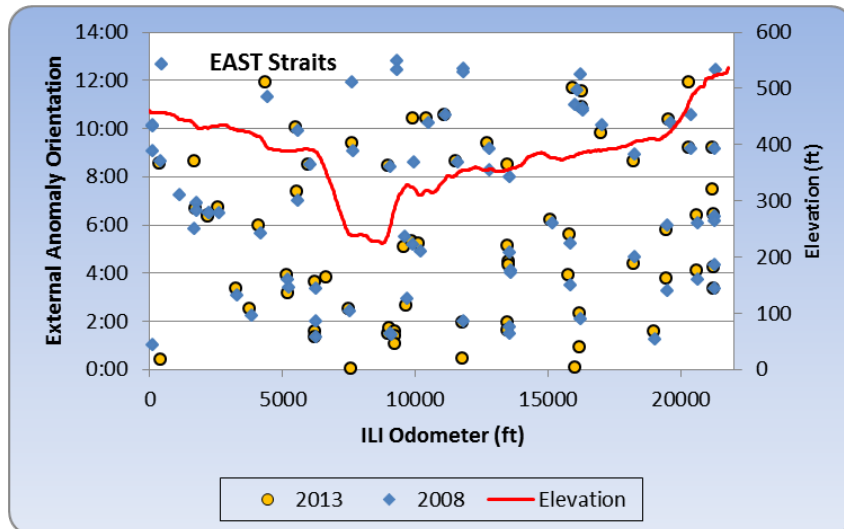
Figure 5. Orientation of external metal loss anomalies in the East Straits.

A check of the distribution of the metal loss anomalies by clock position in Figures 5 through 8, showed no distinct preferred orientations of external nor internal metal loss. Figures 5 and 6 detail the external and internal metal loss orientations along the length of the East Straits, respectively. Likewise, Figures 7 and 8 detail the external and internal metal loss orientations along the length of the West Straits, respectively.

The potential internal corrosion noted above would typically be seen to occur about a preferred orientation which is not the case. It is seen, particularly in Figure 8 that the metal loss orientation is spread throughout the full circumference of the pipe. This then signifies that it is a manufacturing issue. Seamless pipe is known to cause minor metal loss anomalies to be delineated in areas where the wall thickness is non-uniform due to the pipe manufacturing process.

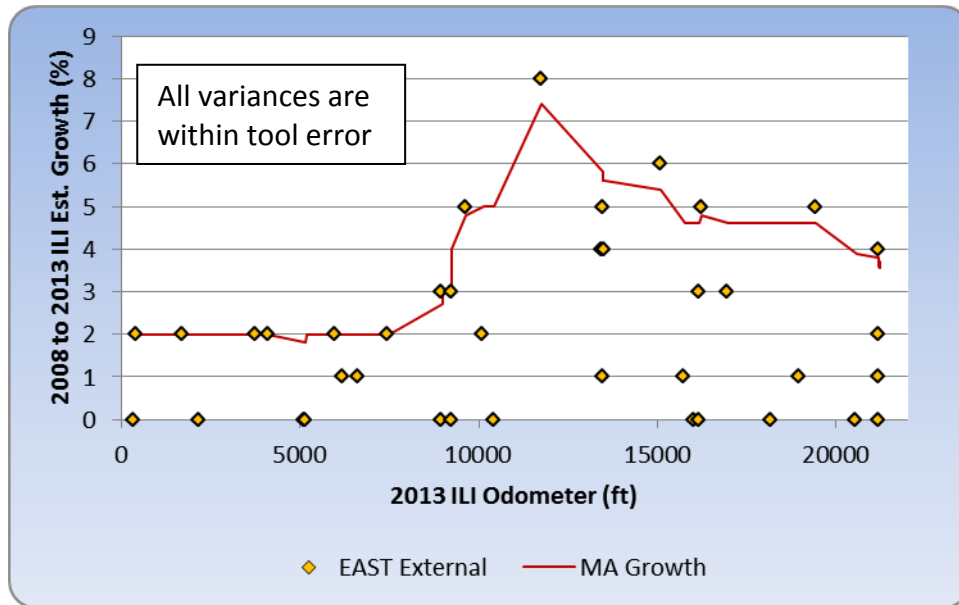
Figure 11. Determinate analysis of growth East external.

If tool error is not considered, the external growth was found to be between 0.0016 – 0.015 in/yr and the internal between 0.0016 – 0.019 in/yr. The corrosion rates for both the external and internal anomalies were calculated using a moving 95th percentile scale as presented in

Figures 11-14. All growth rates were determined to be the 95% confidence interval of growth. Again, the depth variances were within tool error and these rates noted cannot be stated as actual, just used as a worst case estimate.
